# **Asbestos in California**

**Fran Collier**

**Asbestos Site Evaluation, Communication and Cleanup**

**Keystone, Colorado  
September 22—26, 2003**

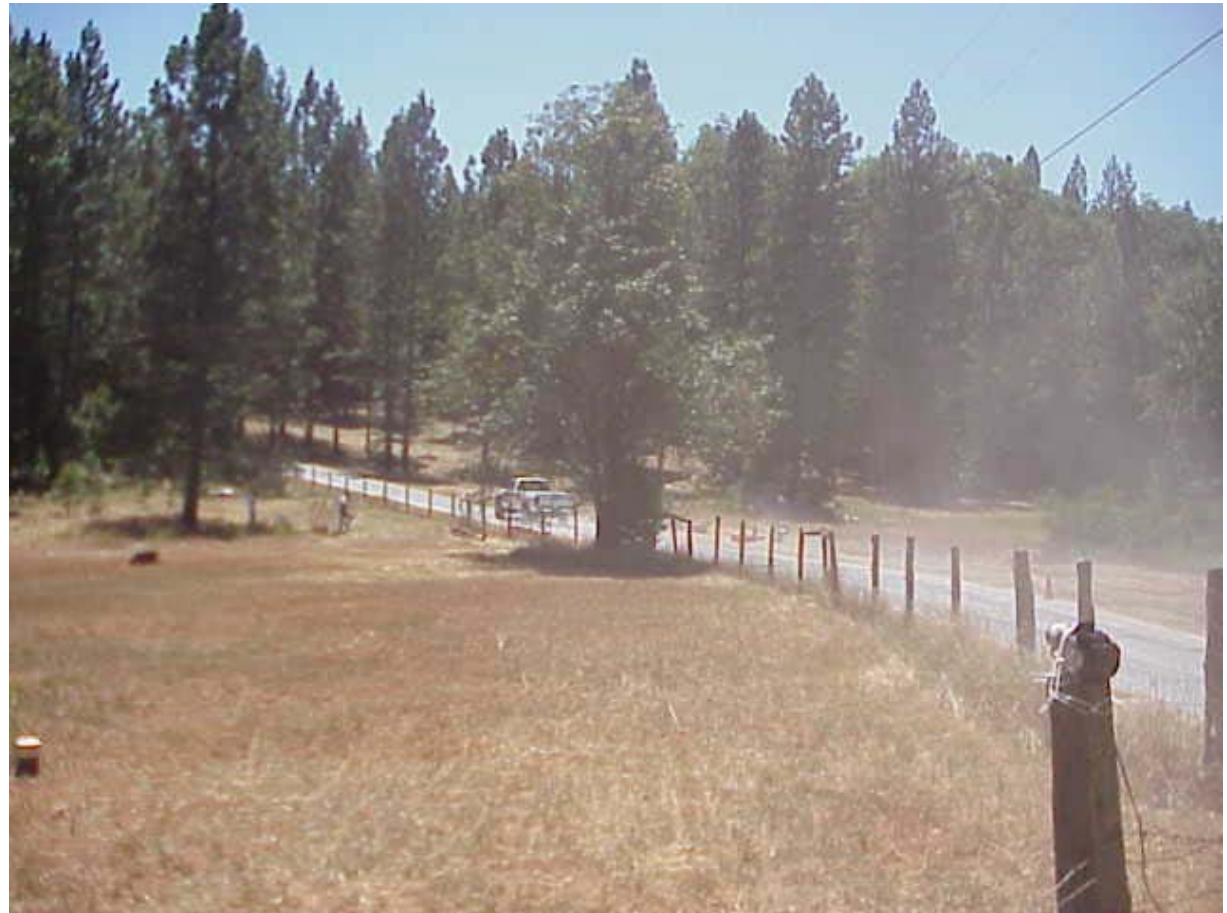
# Serpentine Covered Roads and Road Cuts

- Maps show Ultramafic areas
- Also finding NOA in Mafic areas
- Roads surfaced with serpentine
- Fill materials including decomposed granite
- Alluvial washouts from NOA areas (eg. Arroyo Pasajero)

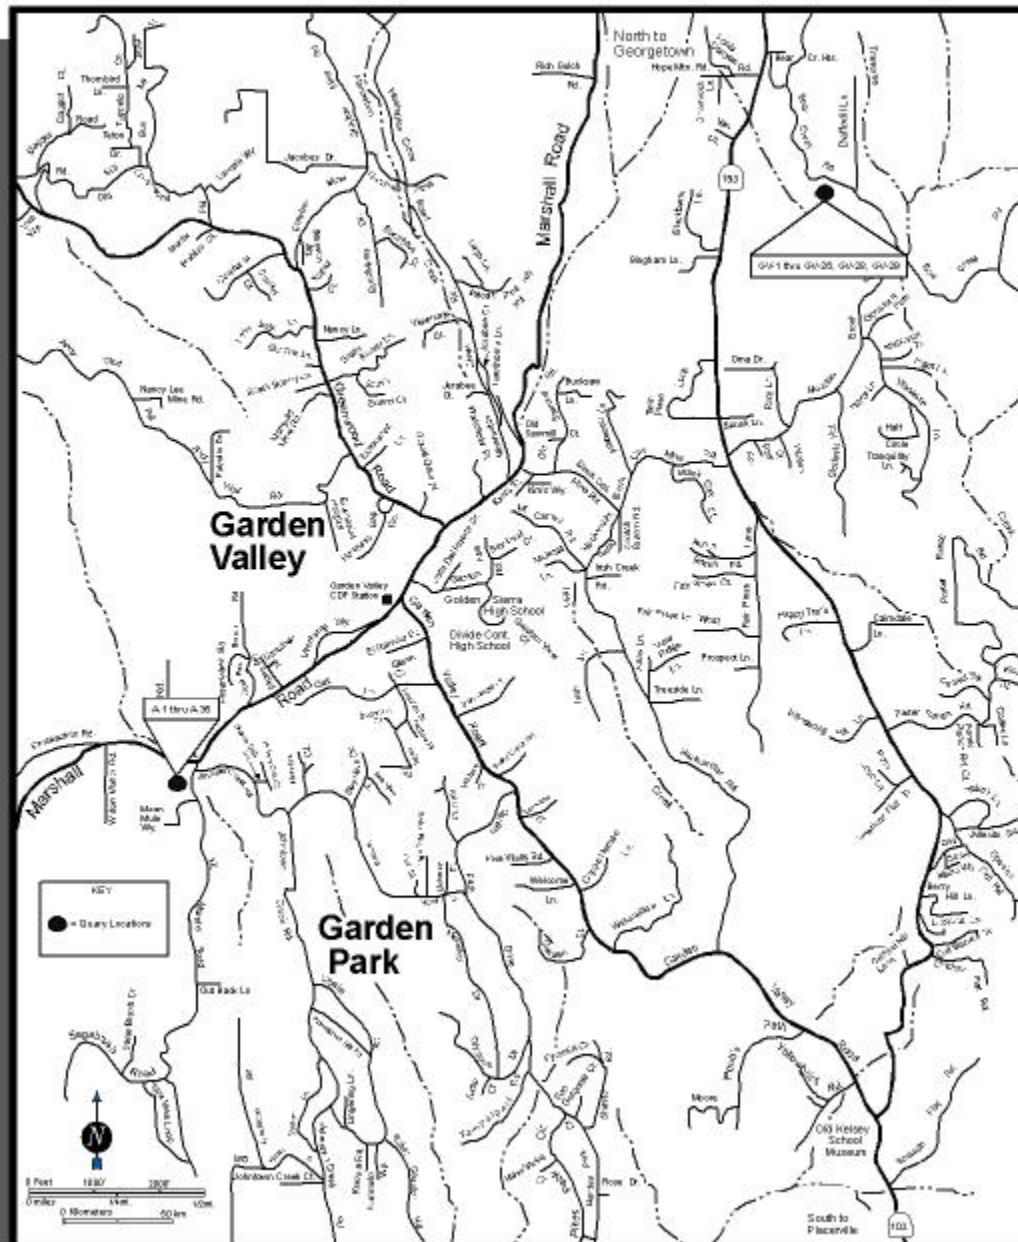
# Garden Valley Site Discovery Area

## Map of Quarry Locations and Sample Numbers

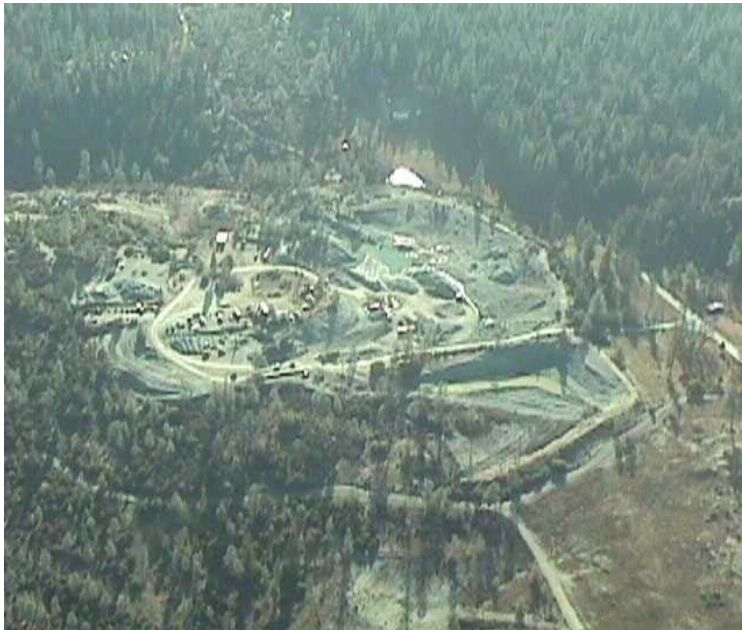
Bear Creek Quarry

# Two Serpentine Rock Quarries

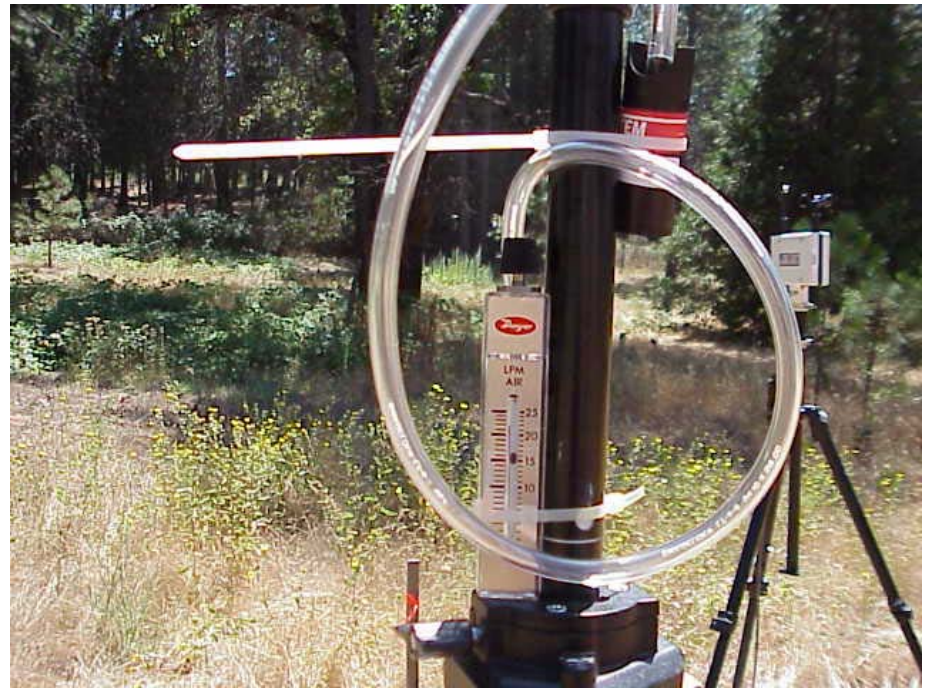
# Air Monitoring Results

- Similar to previous sample results
- All data combined to update risk assessment  $10^{-5}$
- Quarry results similar to those in the community

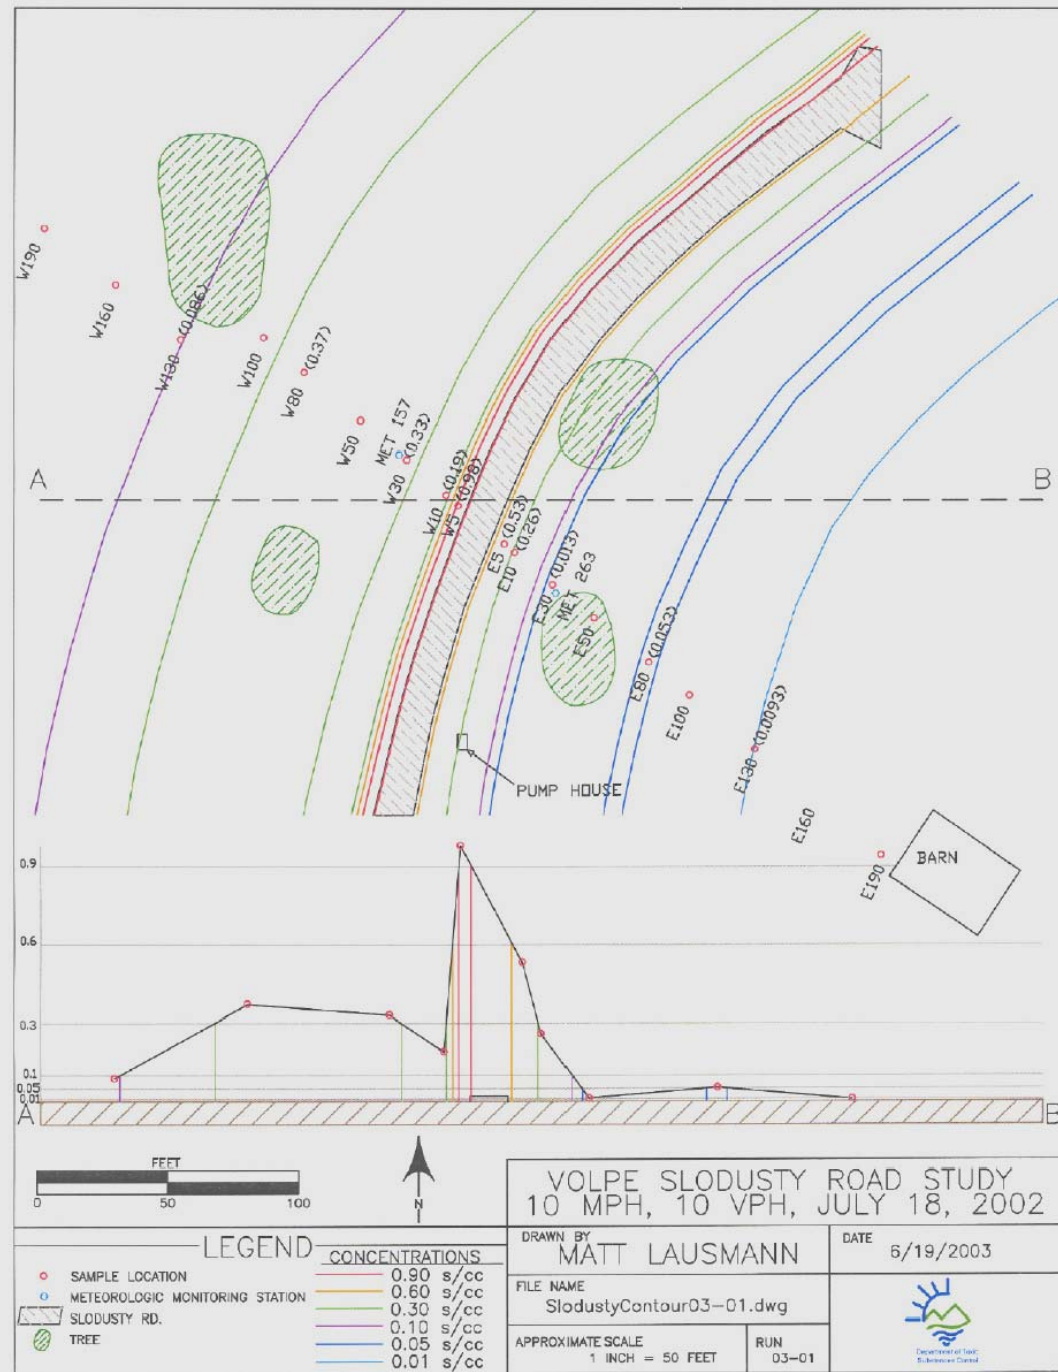
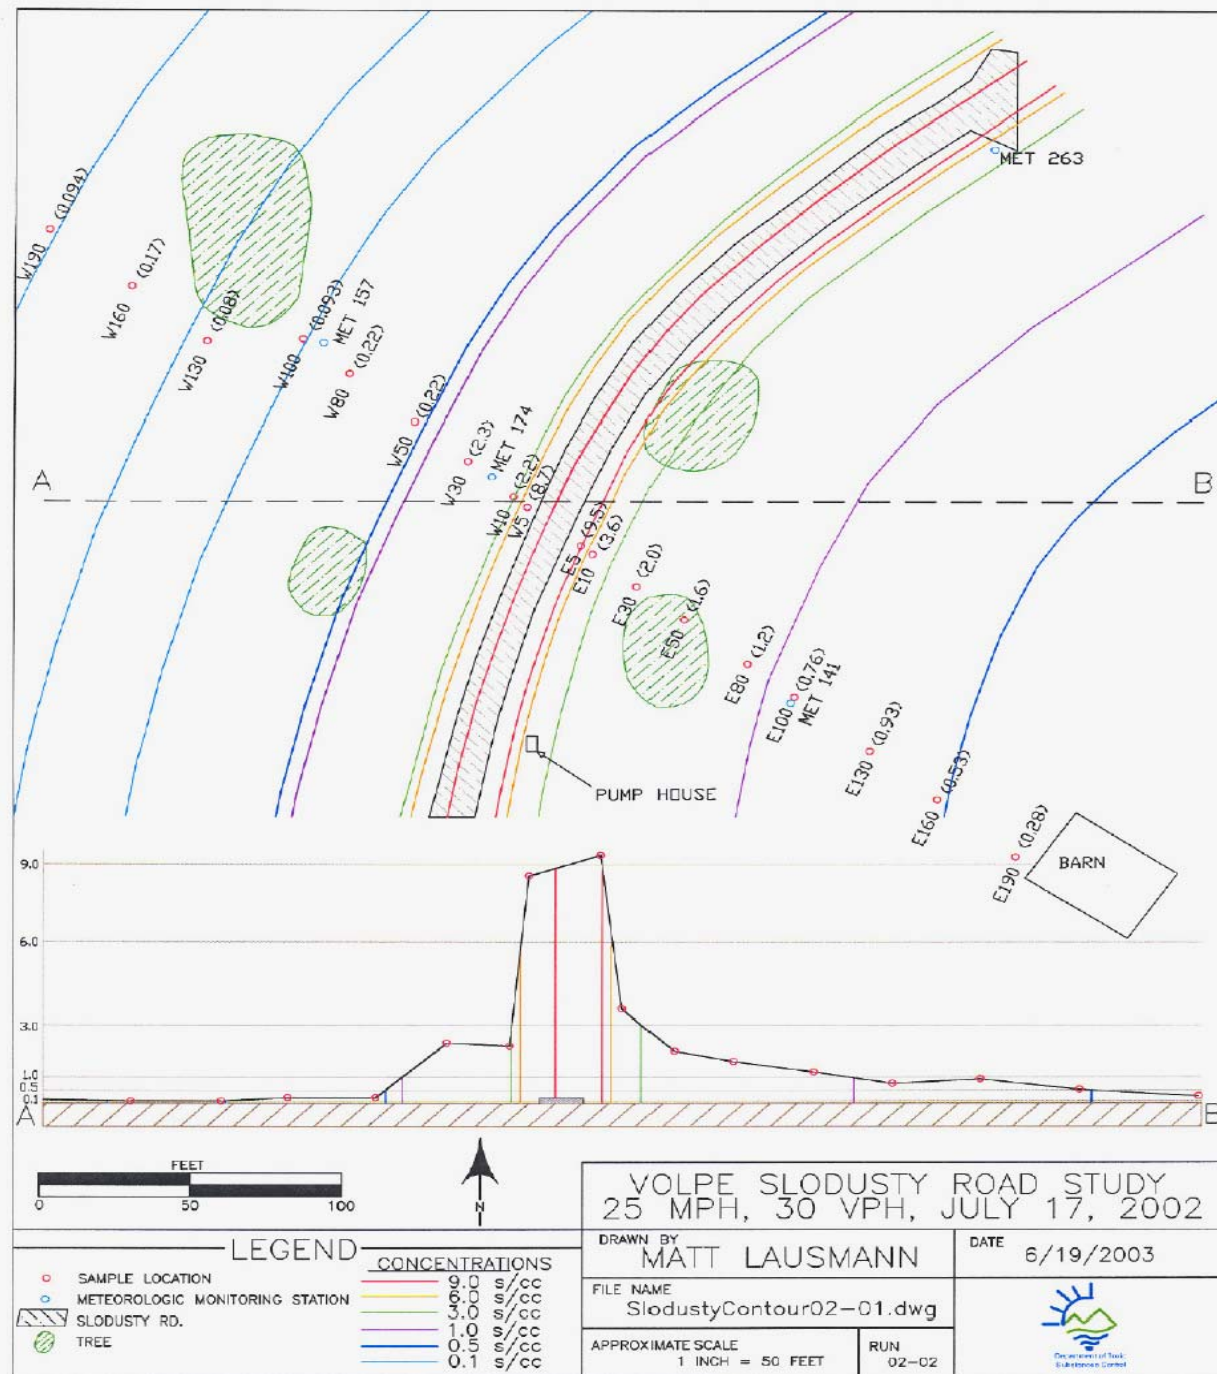
# Slodusty Road Emission Study 10 vehicles per hour at 10 miles per hour

- Conducted on Slodusty Road in July 2002
- Experimental design: Stationary monitors placed at distances from road way
- Ran for duration of specific road test
- Ran 2 tests daily

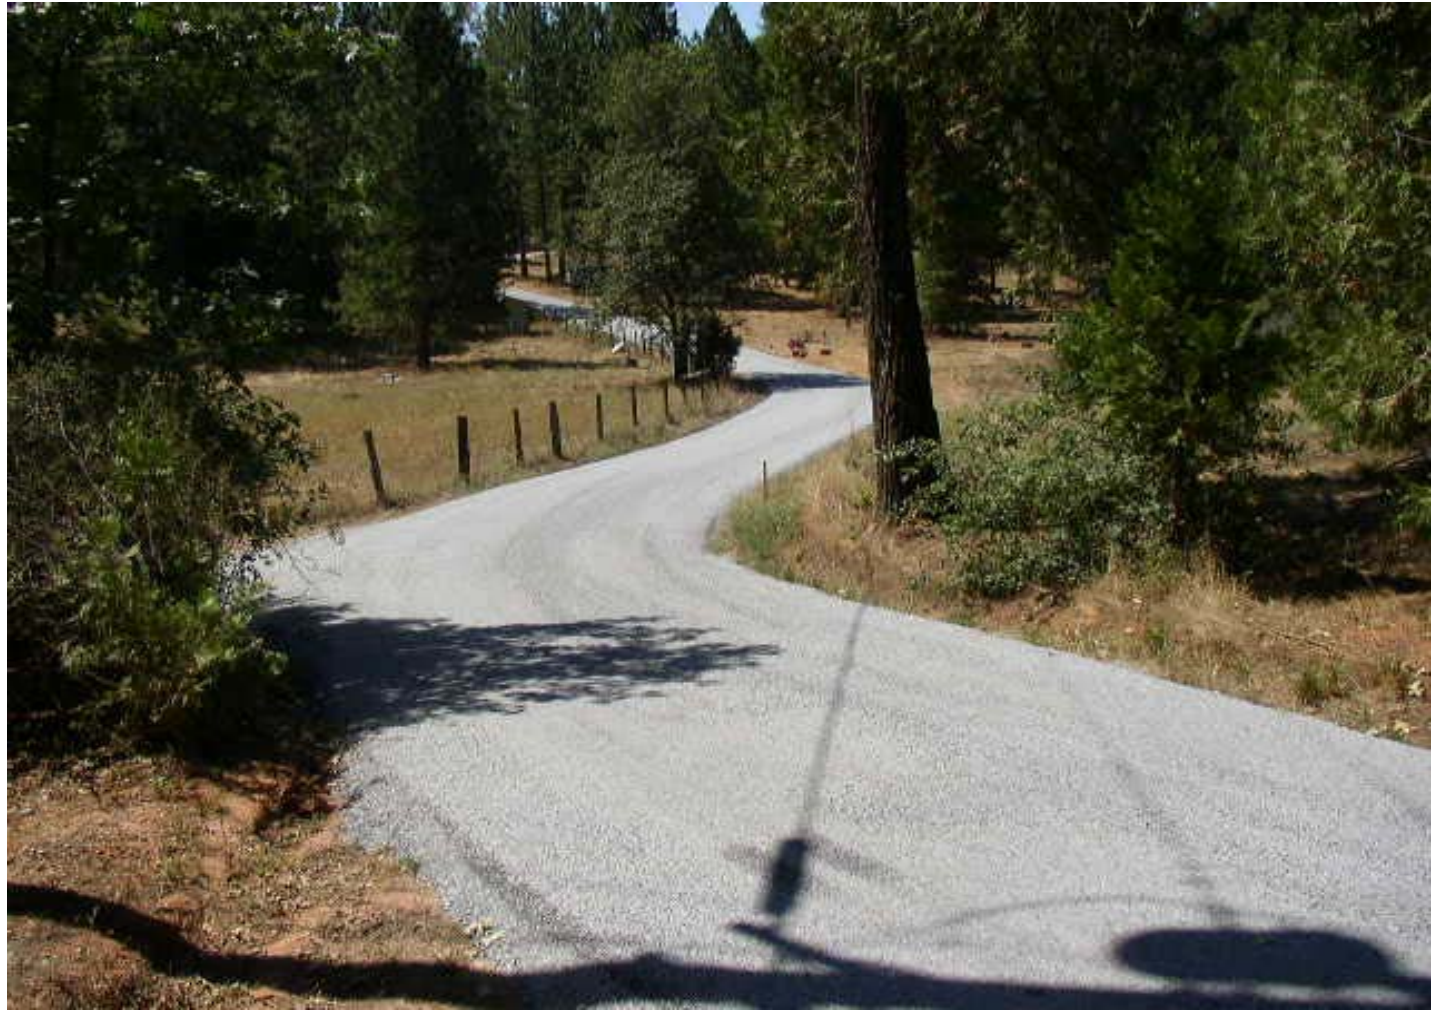
# Slodusty Road

- Resurfaced Slodusty Road
- Chip Seal with Limestone Aggregate Base and oil Emulsion Covered by Limestone Chips

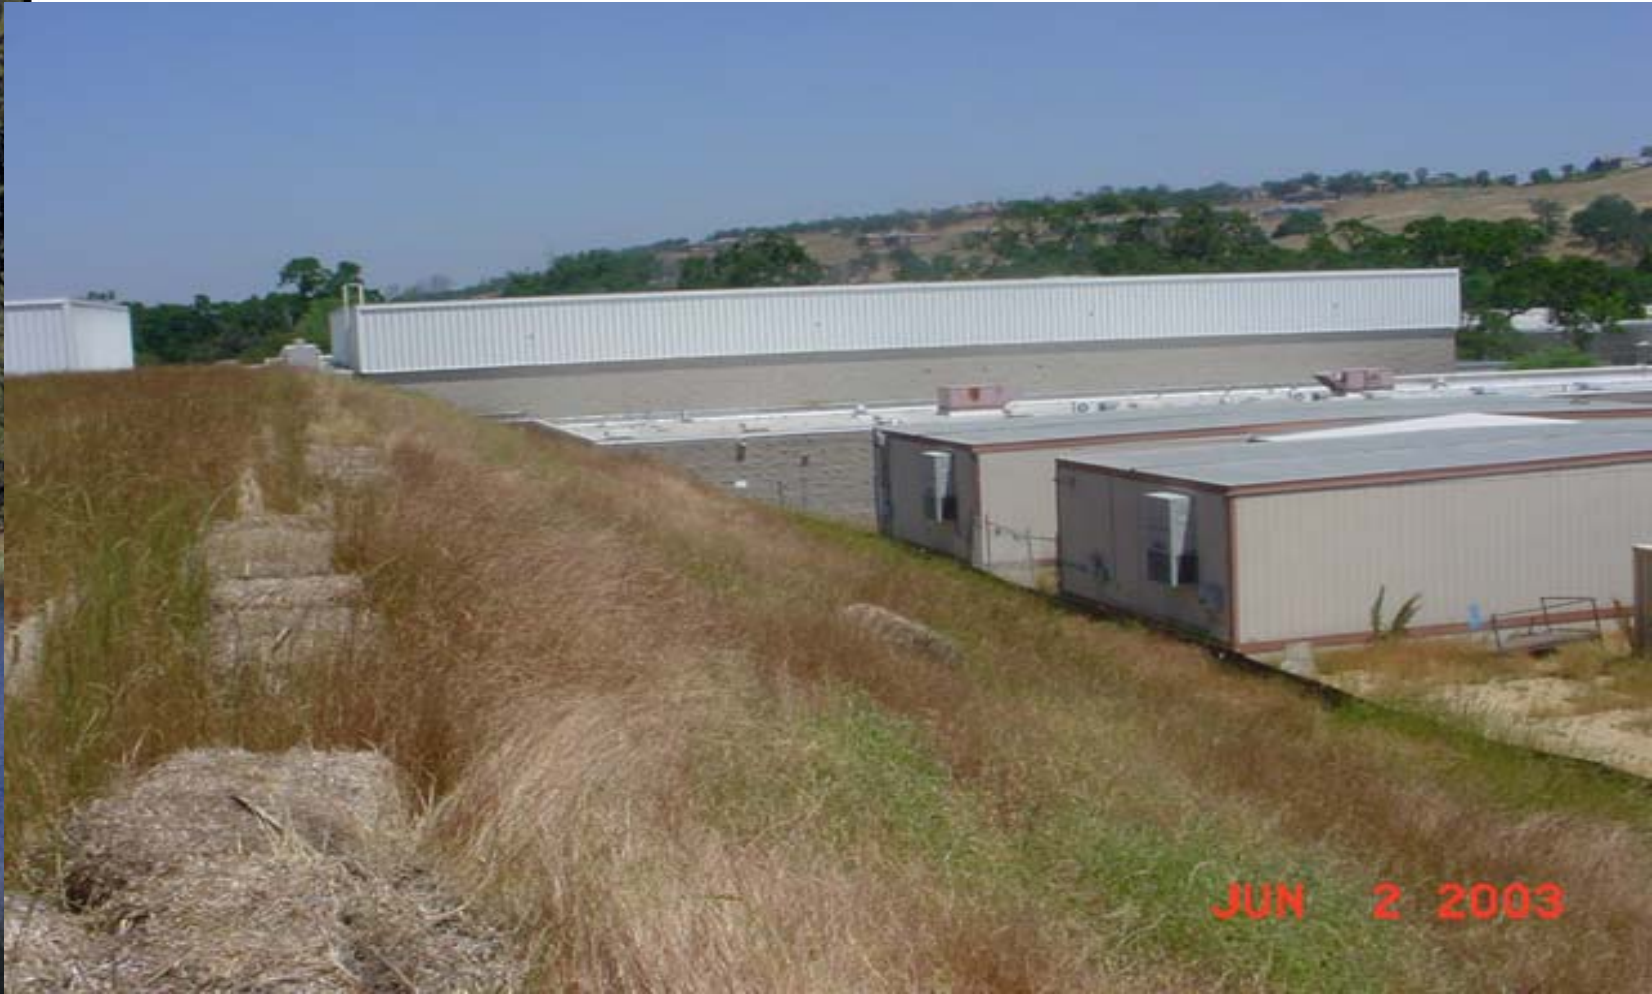
# Soccer Field Before Completion

- Mitigation Phase I started June, 2003
- Cover soccer field with geo fabric, two feet of clean fill and sod
- Shot-crete upper slopes, vegetate lower slopes and restrict access
- Cover exposed areas of school with fill material and landscape/planter boxes or paving.

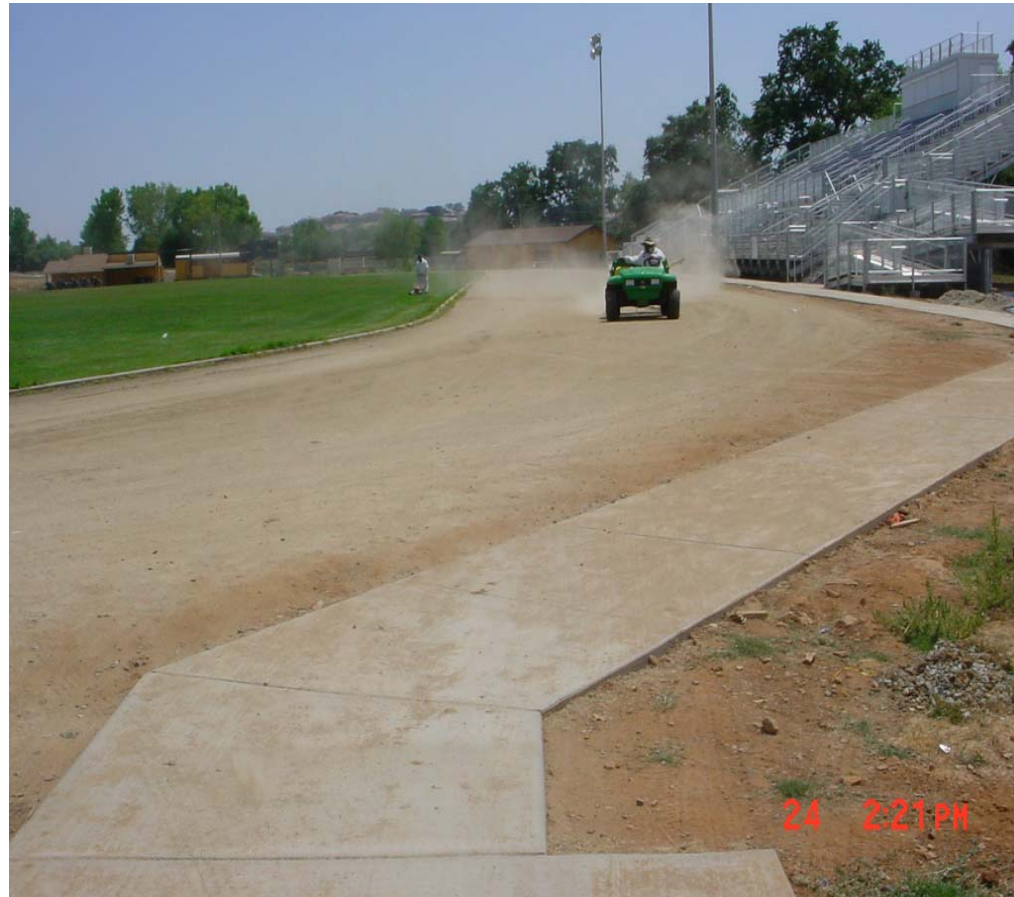
# TRACK Photo

- Activity assessment with stationary monitors
- Track surface is decomposed granite
- Tested by dragging box over track surface to “prep” field for an event.
- Soil samples of decomposed granite collected

- Soil sampling results
- Track decomposed granite sampled with results ranging from 0.001 to 0.02% actinolite by weight
- Imported fill sampled from four possible sources: 3 of the 4 had asbestos detected at  $>0.01\%$  by weight

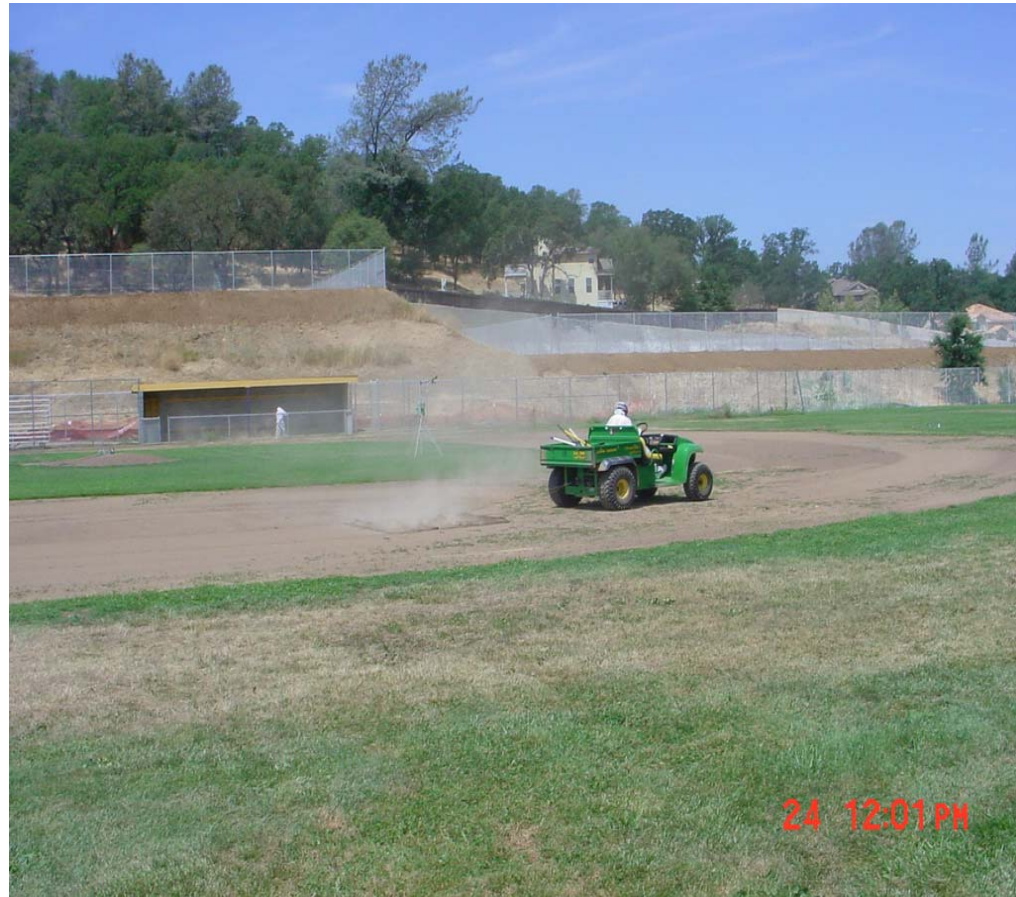
# Baseball Photo

- Tennis Courts and Basketball courts were swept
- Baseball diamond infield was tested dragging box around infield to prep surface
- Stationary air monitoring stations with Met Station
- Low volume personal sampler pumps on workers
